Characterization of Lime Plaster of Ipoh Royal Club for Conservation Purpose

2.0 Case Study: Royal Ipoh Club Building

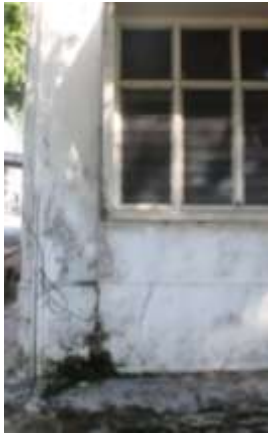
Figure 4a. Mould growth

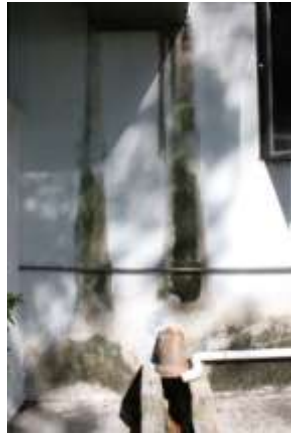
Figure 4b. Greenish stain

Greenish stain was identified most on the surfaces of the walls located in the eastern orientation. These symptoms identified in the wall of the building kitchen due to leakage from ducting. A closer examination of the whole building revealed no symptoms of rising dampness. Defect also occurs due to condensation from air conditioning condensate pipe line. Referring to AbdulGhafarAhmad(2004), subject to building function, structures and effects on building fabric, several factors should be considered before installing air-conditioning units in heritage buildings because some defects such as leakage, dampness, mould growth will occur.

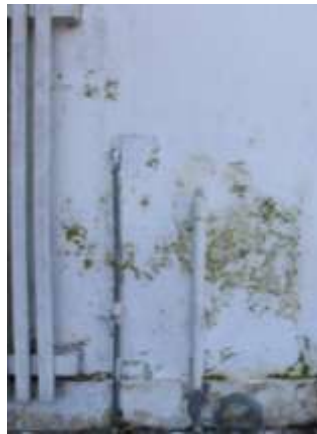
Figure 4c. Greenish stain and peeling of paint

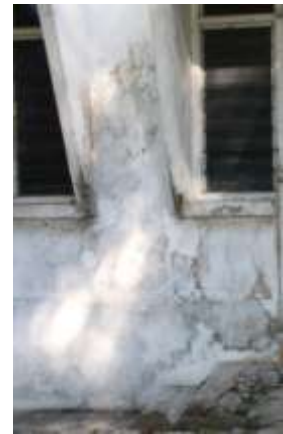
Figure 4d. Stain and crack

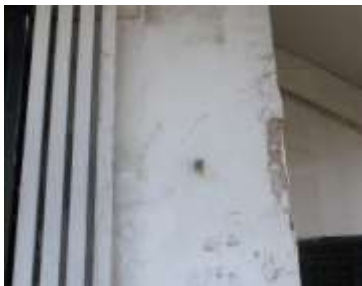
Figure 4e. Cracks in column

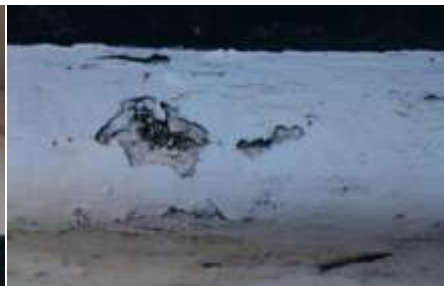
Figure 4f. Blistering of paint and holes

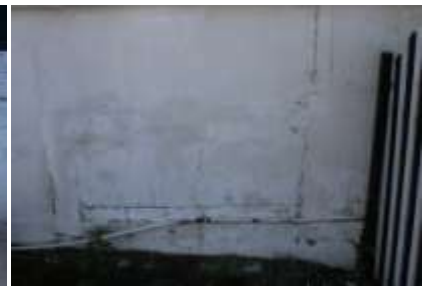
Figure 4g. Crack and stain
